Latent Damage from Single-Event Latchup

**Heidi N. Becker, Tetsuo F. Miyahira
and Allan H. Johnston**

Jet Propulsion Laboratory
California Institute of Technology

2002 Single Event Effects Symposium

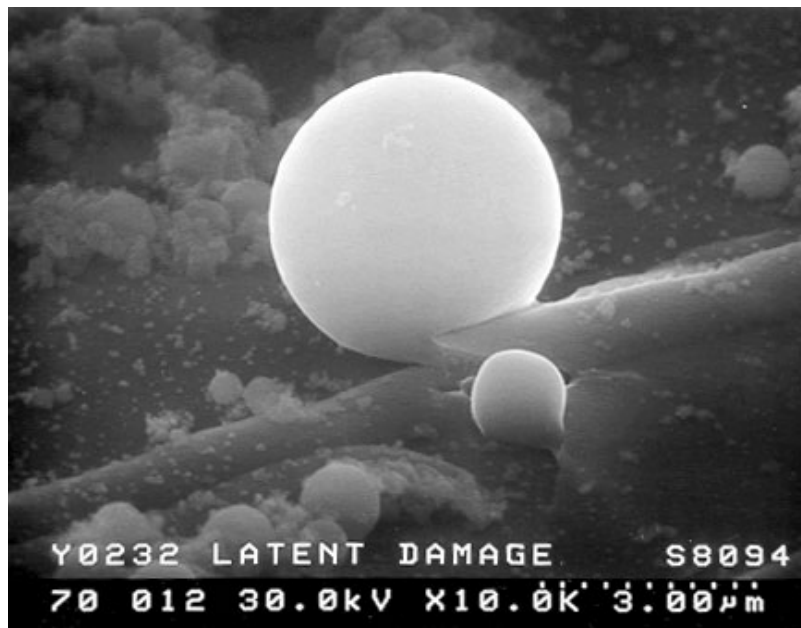
Analysis: A Physical Interpretation

- Critical current density is held long enough to melt interconnect
- Differences in thermal coefficients of expansion of metal and insulator puts mechanical stress on insulator
- Cracking of insulator and eruption of metal occur, often to the point of catastrophic voiding
- As extruded metal cools it forms most efficient spherical shape
